Re: Rockfall Protection System Conformance - Revised
5023 KeikilaniCircle
Honolulu, Oahu, Hawaii
TMK 3-6-023:006

Ref: Atlas Geotechnical, 28 April 2015, "Rockfall Hazard Assessment and Mitigation,
5023 KeikilaniCircle, Honolulu, Oahu, Hawaii, TMK 3-6-023:006."

Re: Rockfall Hazard Assessment and Mitigation
5023 Keikilani Circle
Honolulu, Oahu, Hawaii
TMK 3-6-023:006

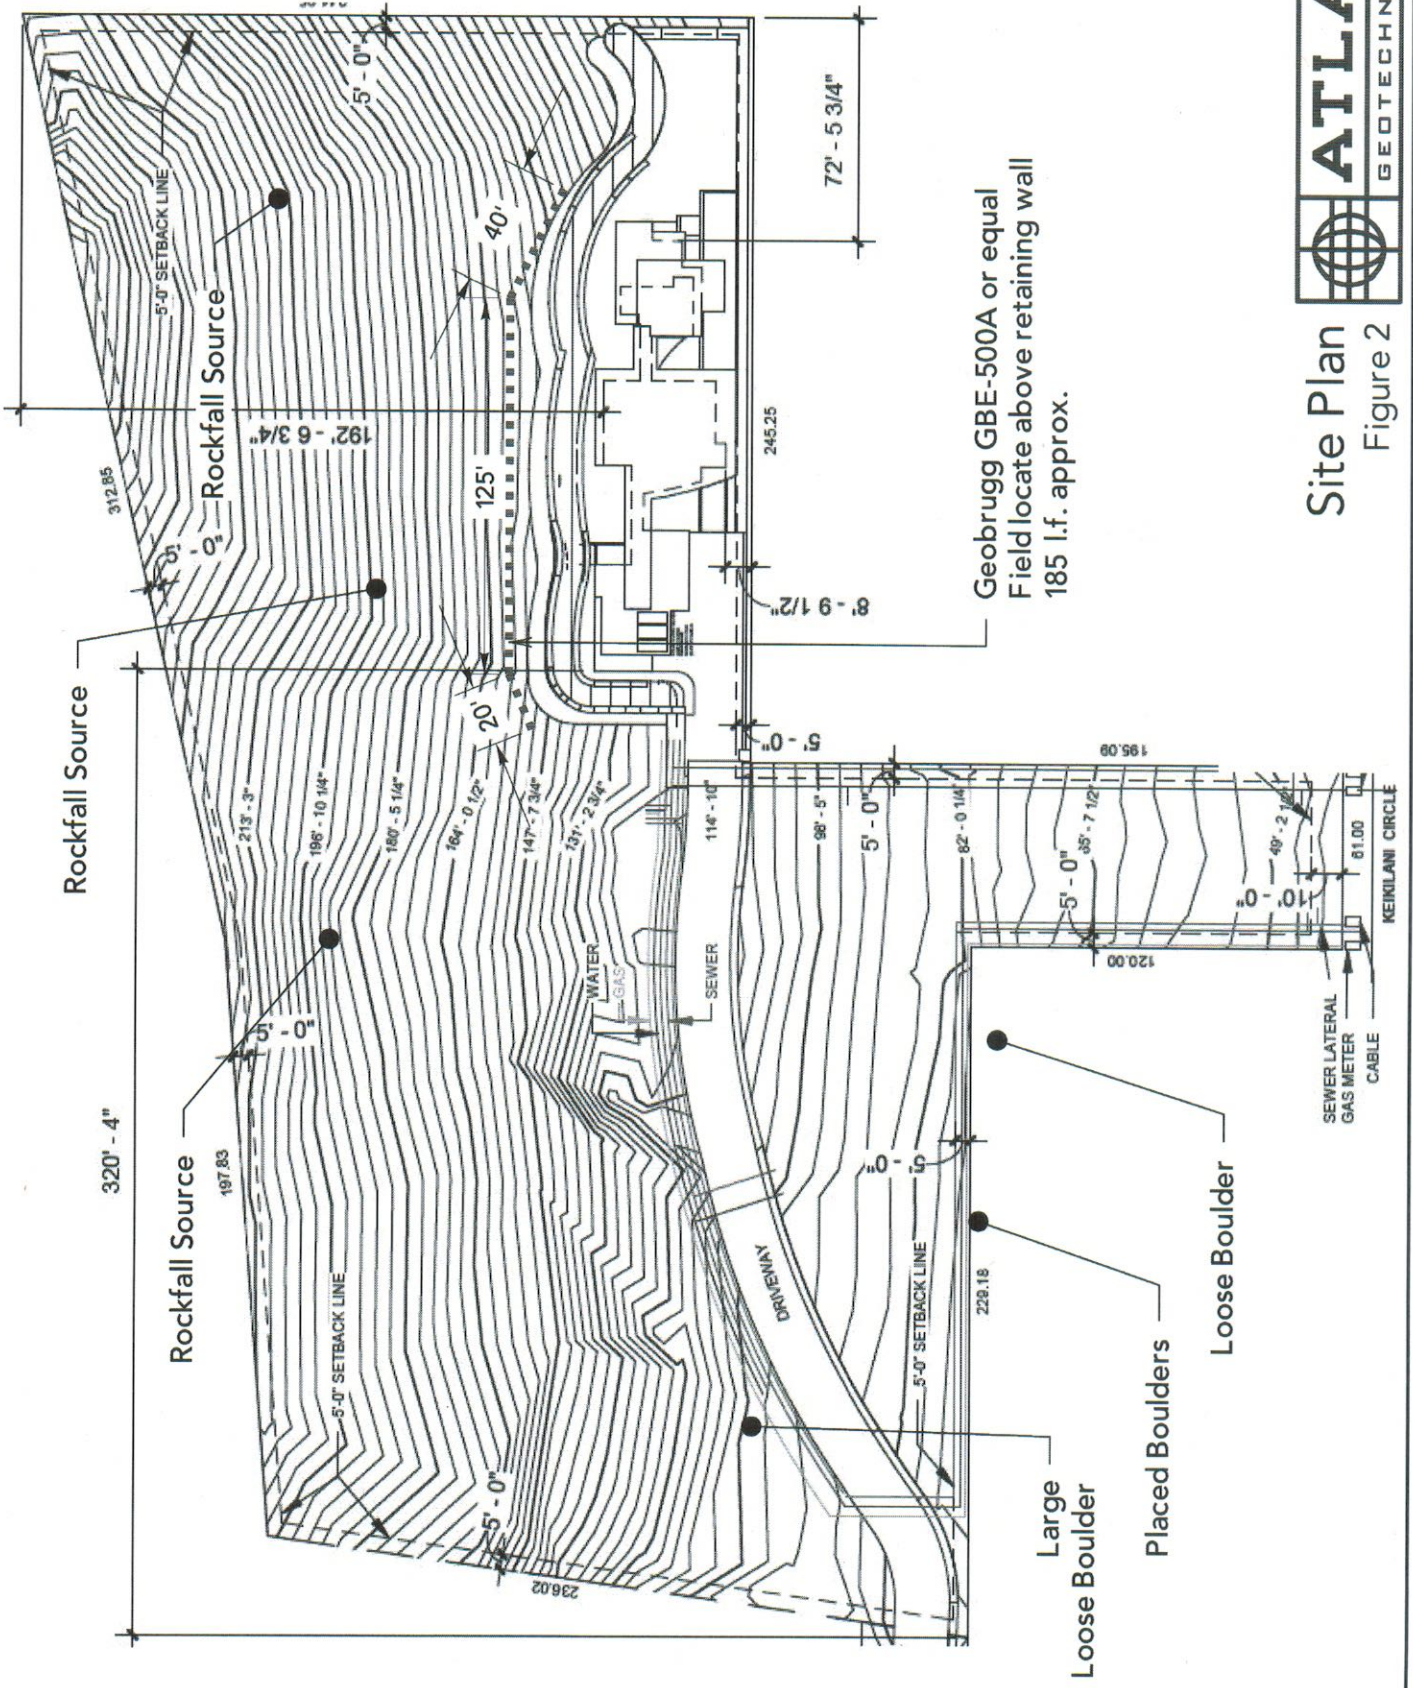
Site Plan
 Figure 2

The boulder source zones are three or more terraces located above the elevation of the proposed construction (Figure 2). The source materials are generally erosion-resistant basalt flow layers that have formed near-vertical bluffs 12 to 20 feet high. We did not observe any boulders that appeared imminently unstable. We did observe one very large boulder that appeared to be loose on the grade, though flat topography immediately adjacent to the rock limits its mobility.

Geobugg GBE-500A or equal
 Field locate above retaining wall
 185 l.f. approx.

- 3.1. Considering the relatively small scale of the development, we recommend that the fence be continuous across the top of the development.
 - 3.2. Figure 2 shows a conceptual barrier alignment; we recommend that the installation contractor adjust as necessary to suit observed site conditions.
